SILT POND B

(NDI Number PA 00824

UNITED STATES STEEL CORPORATION,
RAW MATERIALS DIVISION.

PHASE I INSPECTION REPORT.
NATIONAL DAM INSPECTION PROGRAM

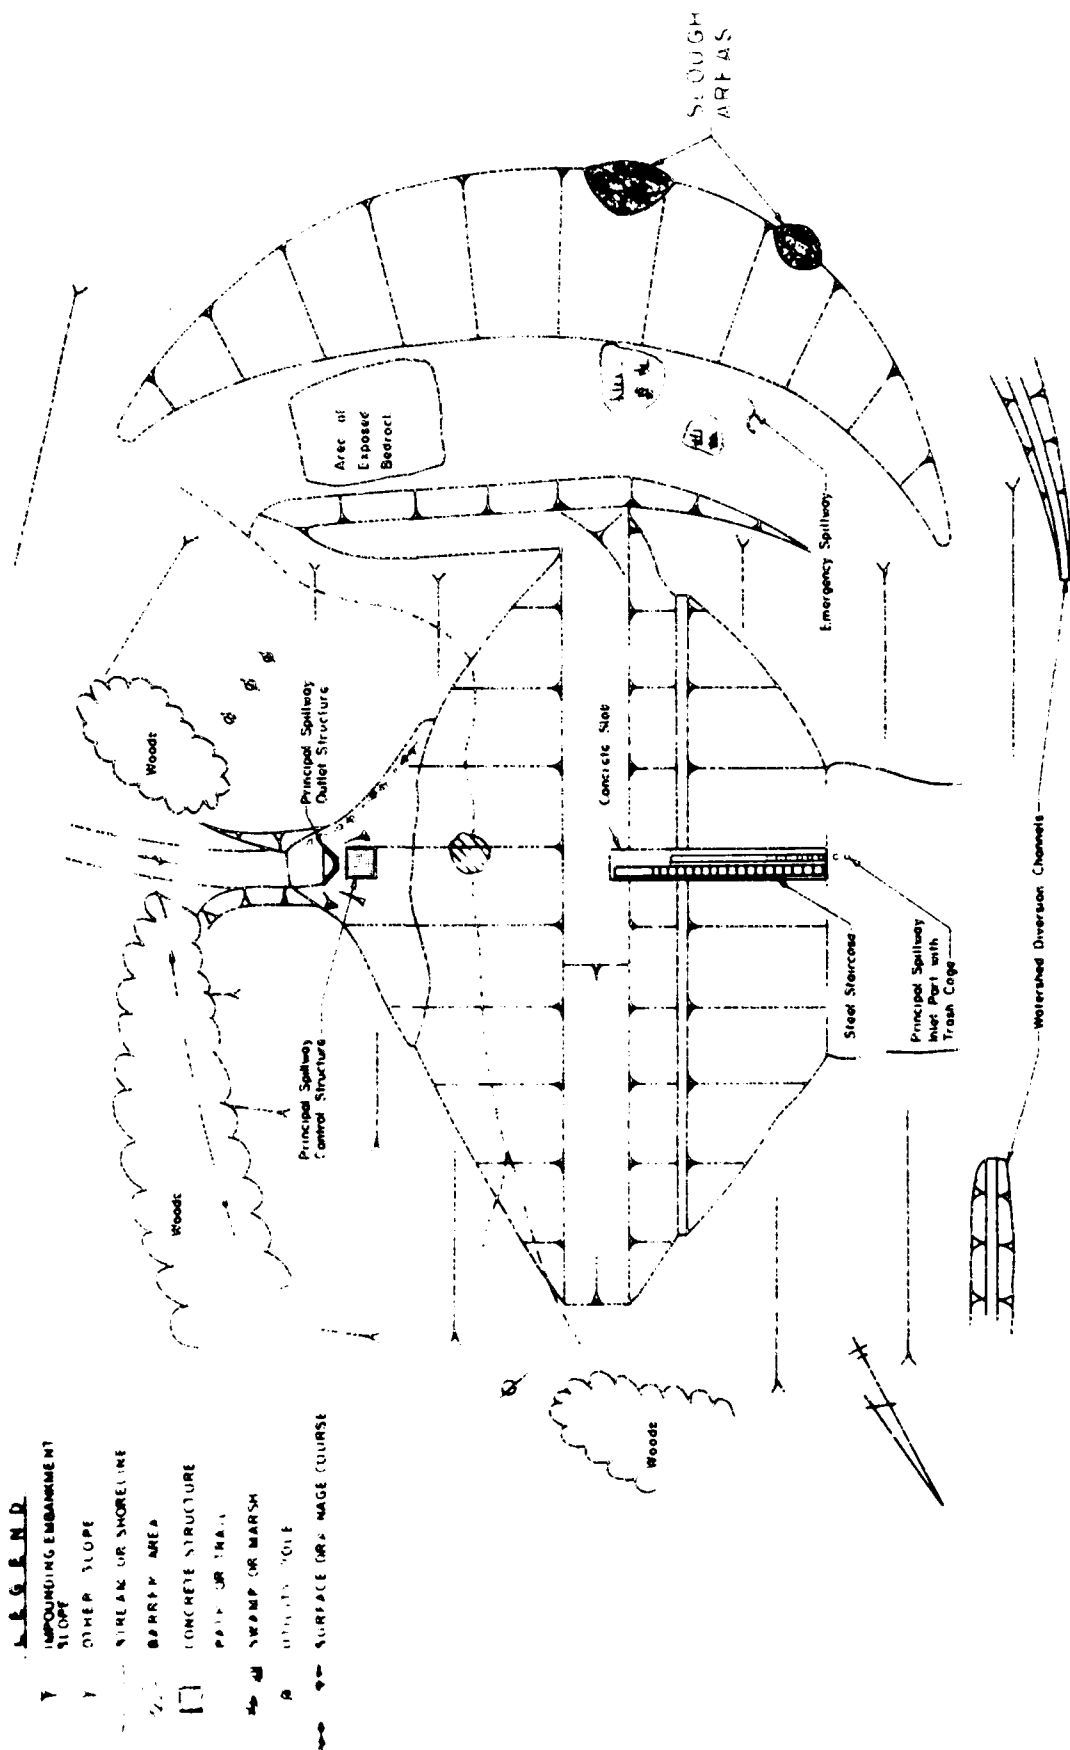
DATE: MARCH 1981		SILT POND B		FIELD SKETCH	
SCALE: NONE		NATIONAL DAM INSPECTION PROGRAM			
DR: JF	CK: JEB	ACKENHEIL & ASSOCIATES		CONSULTING ENGINEERS	
DWG. NO. 80138D-1		GEO SYSTEMS, INC.		1000 BANKSVILLE RD. PITTSBURGH, PA. 15216

VISUAL EXAMINATION OF	OBSERVATIONS	REMARKS OR RECOMMENDATIONS
SURFACE CRACKS	None observed.	A wet zone was observed about midway down the embankment's downstream slope approximately on the line of the outlet works conduit. The area was barren and muddy but gave no indication of continuous seepage flows. Field measurements indicated that the area in question was approximately six feet above the reservoir pool elevation.
UNUSUAL MOVEMENT OR CRACKING AT OR BEYOND THE TOE	None observed.	
SLOUGHING OR EROSION OF EMBANKMENT AND ABUTMENT SLOPES	Two small slough zones were observed at the top of the emergency spillway's right (cut) slope. The slough lengths were approximately 20 and 30 feet, respectively. No other indications of instability of embankment or abutment slopes were observed.	
VERTICAL AND HORIZONTAL ALIGNMENT OF THE CREST	The embankment crest was straight and approximately level throughout the right central portion of the embankment. A noticeable depression of the left central portion of the crest was observed. Near the left abutment the crest rose slightly and approached a diversion ditch excavated into the abutment. At the right end of the embankment, the upstream side of the crest dropped slightly toward the emergency spillway.
